Design and Construction of Single Lane Road Bridge

Abstract

Bridges in the Kachchh region are generally stream or railway crossings. The affected area has significant road and rail networks. There are several major highway and railway bridges, and many small to medium bridges. As per Roads and Buildings (R&B) Department of the Government of Gujarat, 900 km of roadways and over 500 bridges were damaged in the January 26, 2001 earthquake.

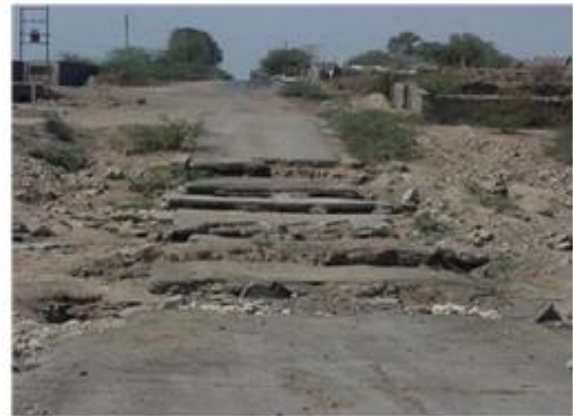
Figure 2: Collapse of structure between towns of Anjar and Bhuj.

Lack of structural adequacy resulted in the collapse of several traffic-bearing roadway drainage structures, as shown in Figure 19-2. Such roadway drainage structures were, in most cases, concrete box culverts, concrete

pipes and unreinforced masonry box culverts. To accommodate postearthquake traffic, temporary detours were provided across adjacent dry-season riverbeds. Damaged drainage structures are not repairable, and need to be rebuilt with adequate attention to quality in design and construction.

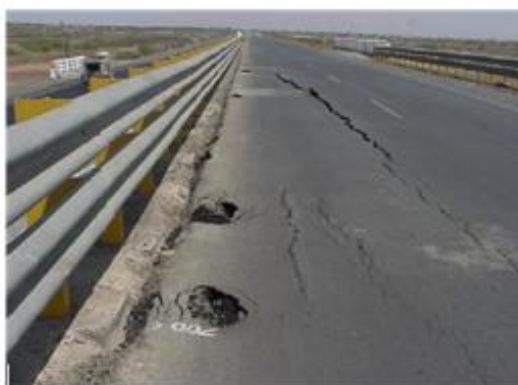
Figure 1: Roadway cracking between the roadway drainage towns of Gandhidham and Bhachau.

Newly finished roadways between the towns of Gandhidham and Bhachau suffered some damage. Settlement of the shoulder edge and holes about 600 mm in diameter and 450 mm deep are also visible in the photo. A longitudinal crack separated the entire guardrail system from the roadway shoulder. While rock blocks were laid and mortared in place on the face of the slope, earthquake caused settlement and down slope movement of the underlying soil.

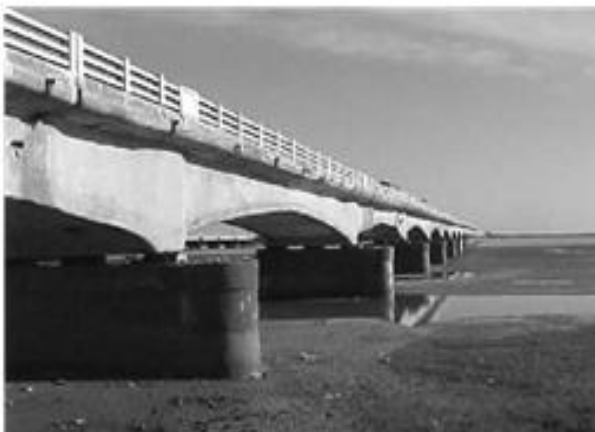
Figure 3. Old Surajbadi Highway Bridge

The Old Surajbadi Highway Bridge across the Little Rann of Kachchh on National Highway 8A (NH8A), is the longest bridge in the region. It was built in the 1960s at the same time as the Surajbadi Railway Bridge (see below) and parallel to it. It suffered significant damage in the January 26, 2001 earthquake due to lack of ductility, damage to bearings, shear failure of the hinges, and significant ground movement and liquefaction.

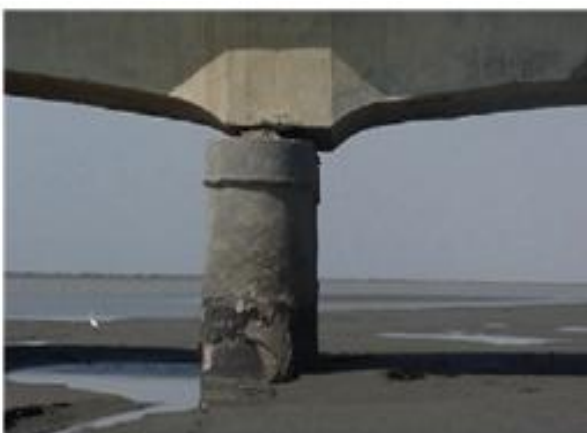
Figure 4. Relative longitudinal movement between the piers and the superstructure spans in the Old Surajbadi Highway Bridge.

There is no continuity or ductility in the structure; therefore each span acted independently and the entire structure experienced a collection of out-of-phase dynamic motions. As a consequence, the bridge suffered damage due to pounding of the superstructure spans at the balanced cantilever joint locations. The expansion joints were closed, rotated, and had popped out throughout the bridge. The concrete handrails and balusters at the expansion joints sheared off at the connections. The cracks in the balusters extend into the bridge deck slab.

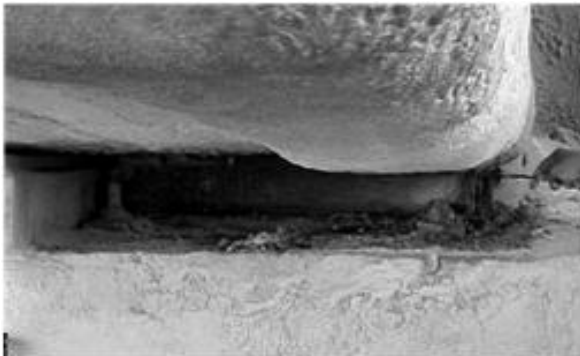
Figure 5. Roller bearing on the north side

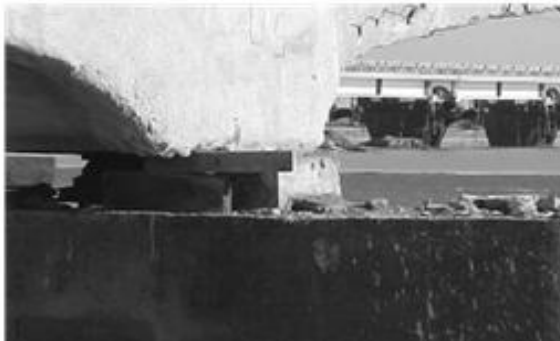
Figure 6. Damaged bearing on Old Surajbadi abutment of the Old Surajbadi Highway Bridge.

The New Surajbadi Highway Bridge (under construction) can be seen in the background.

The bearings and expansion joint at the abutment are completely dysfunctional and may not be repairable. Even though there were no transverse stops to prevent such lateral movement of the superstructure spans, the large size of the pier cap prevented the spans from dislodging.

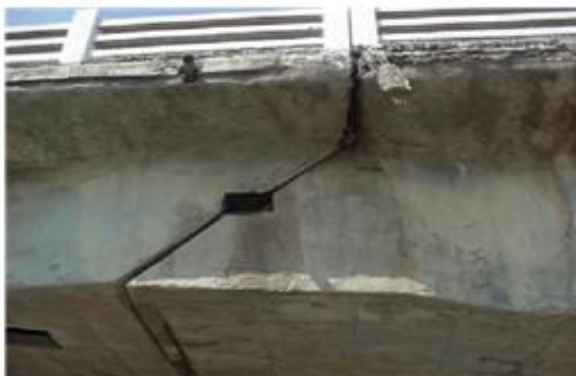
Figure 7. Failure of in-span hinge and traffic railings at Old Surajbadi Highway Bridge.

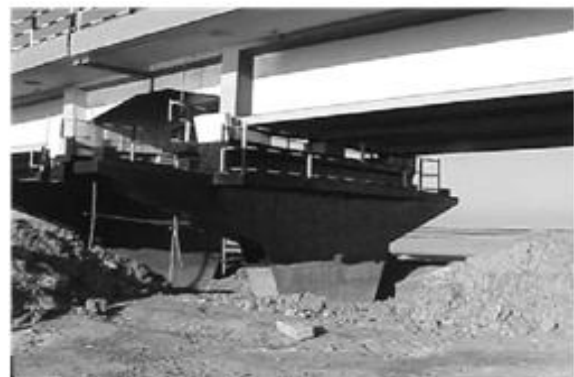
Figure 8. Girder-pier support system on the Well foundation bearings of the New Surajbadi Highway Bridge. is not visible.

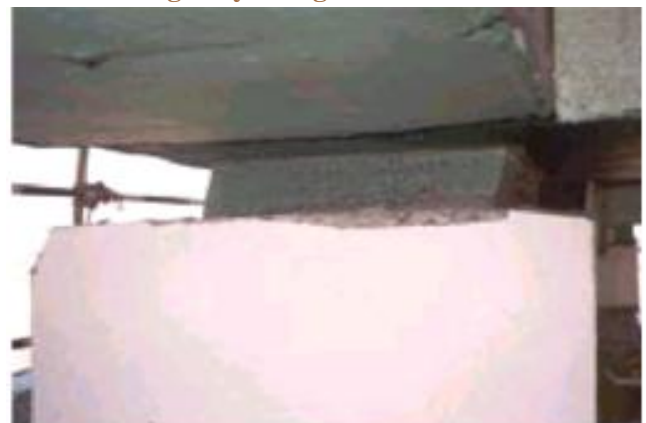
Figure 9. Severely strained elastomeric New Surajbadi Highway Bridge.

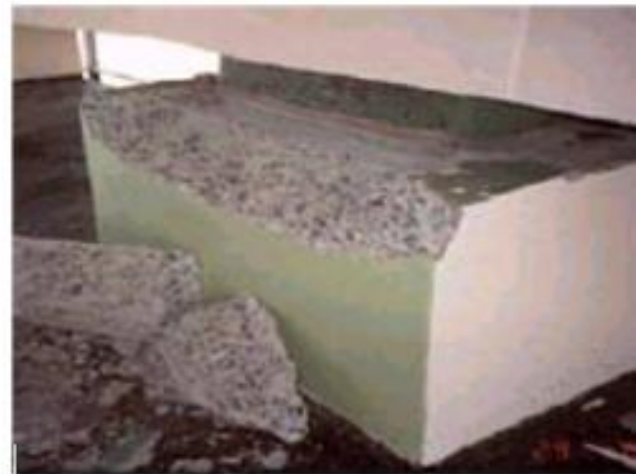
Figure 10. Damaged concrete pedestals of the elastomeric bearing of the New Surajbadi Highway Bridge.

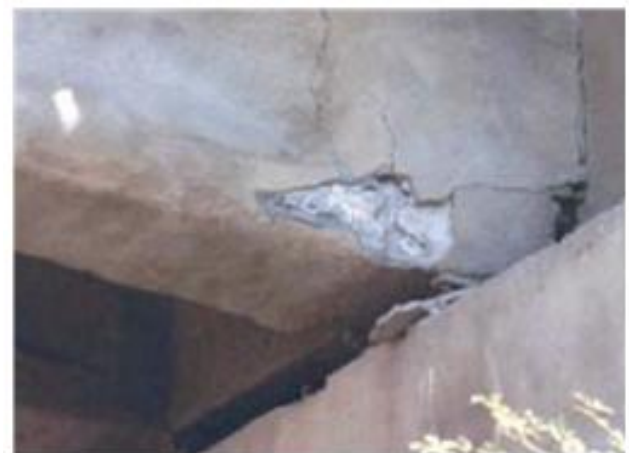
Figure 11. Damaged soffit of the girder at the span ends of the New Surajbadi Highway Bridge.

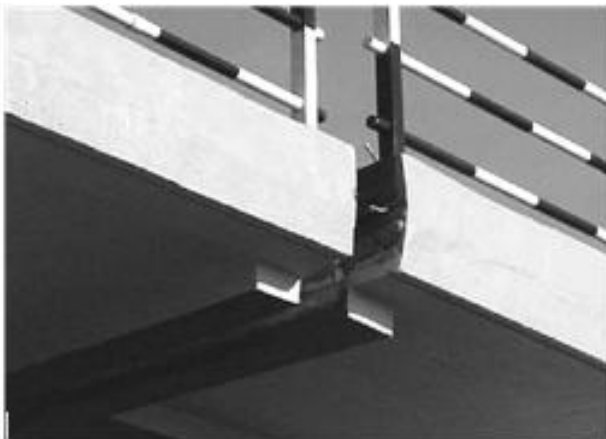
Reinforced concrete stoppers were provided on the pier supports to limit the lateral seismic displacement of the girders. The gap on either side between the girders and the stoppers was about 115 mm. Almost all stoppers were damaged in the earthquake due to pounding by the girders, indicating a significant lateral motion of the girders during the earthquake. These stoppers definitely came into use during the January 26 earthquake. Although they have been damaged in their service, they also seem to have stopped the bridge deck from coming off its support. Figure 19-12 shows two damaged stoppers, one of them with a large 127 mm wide crack.

Figure 12. Transverse displacement of the New Surajbadi Highway Bridge.

The girders were jacked up and repositioned, the alignment of the bridge was restored, the last two spans

were completed, and the damaged reinforced concrete stoppers were reconstructed.

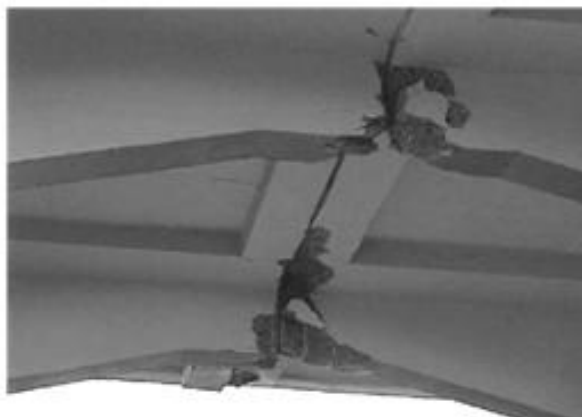
Figure 13. Pounding between two adjacent superstructure decks of the New Surajbadi bridge spans, Highway Bridge.

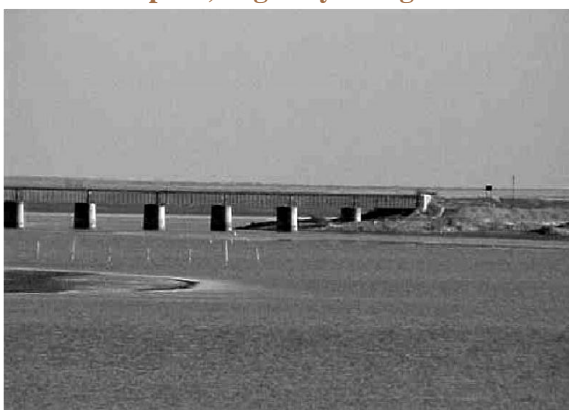
Figure 14. Near the south side abutment of the Surajbadi Railway Bridge.

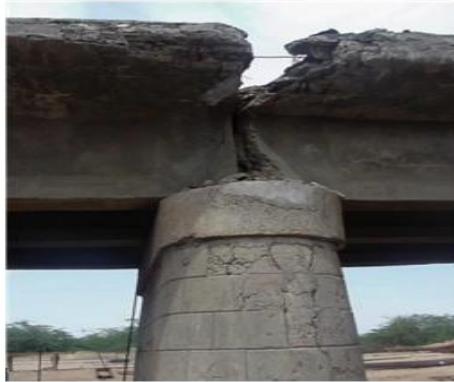
Out-of-phase and uncontrolled movement of the bridge elements resulted in pounding at the expansion joints and dislocation of the superstructure at the bearings. Most of new bridges were identical in design and construction, and therefore this damage was typical. In some cases, the expansion joint shifted on the pier wall. Due to the poor condition of the concrete, damage of the slab at the expansion joint grew to include the cantilever slab. The substructure experienced diagonal cracking in the pier cap and vertical cracking in the wall pier. Cracks are 12 to 25 mm wide and will require immediate repair.

Figure 15. Failure of the girder end and expansion joint of a bridge between the towns of Gandhidham and Bhachau.

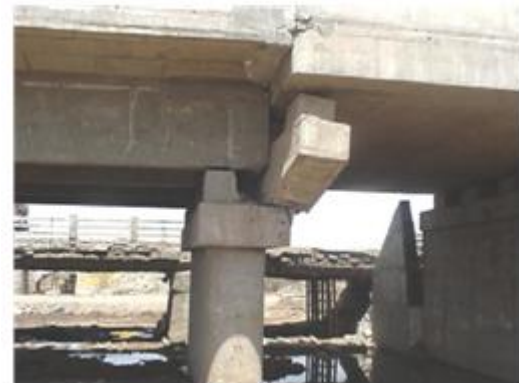
Figure 17. Failure of crossbeam of a bridge at the village Vondh.

difference in superstructure depth, an auxiliary crossbeam (about .5 m deep) was extended from the top of the wall-type reinforced concrete pier; the reinforced concrete bed-blocks for the bearings of the shallow slab of the short span were rested on this. Thus, the end faces of the girders in the adjoining long span were butting against this crossbeam. The longitudinal movement of the girders of the long span during the earthquake caused pounding of the girders on this auxiliary crossbeam; the fixed connection between the crossbeam and the pier cap failed. The expansion joint at this pier shifted about 300 mm from the centerline of the pier.

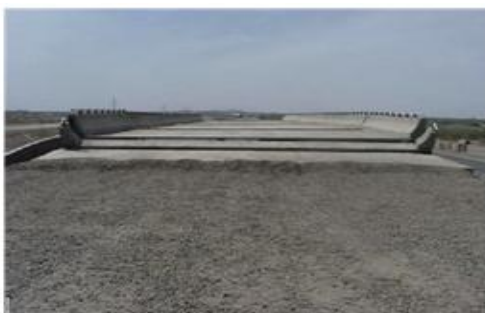
Figure 16. Failure of approach slab of a bridge at the village Vondh.

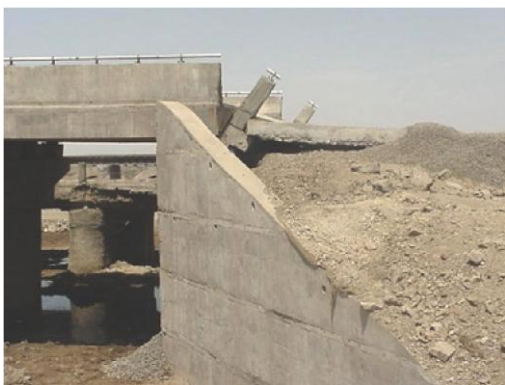
Further, due to the relative longitudinal movement of the bridge superstructure and the abutment, the superstructure pounded on the abutment backwall and caused cracking and spalling of the concrete at the base of the backwall. In turn, the backwall of the abutment also pushed into the approach slab. The approach backfill settled and spread out toward the wing walls on the side.

Figure 18. Failure of abutment of the bridge at the village Vondh.

Settlement of the approach backfill of between 300 and 450 mm was noticed in this short-span bridge. The repair of this bridge will require extensive work, including rebuilding of the abutment wall, expansion joint, backwall, wingwalls, backfill and approach slab.
