Impact of Fire on Steel Reinforcement of R.C.C Structures

Abstract:

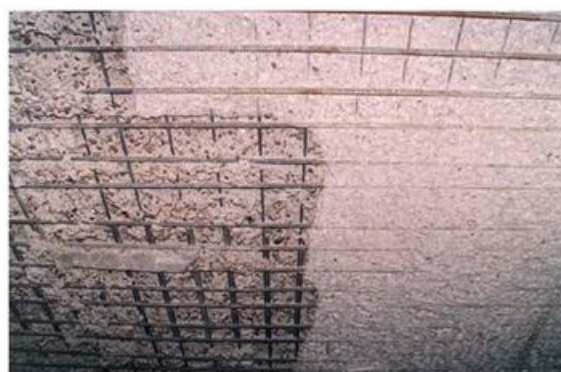
Fig 1.1: fire damaged slab

1. Most of the structures were repaired. Of those that were not, many could have been but were demolished for reasons other than the damage sustained.
2. Almost without exception, the structures performed well during and after the fire.

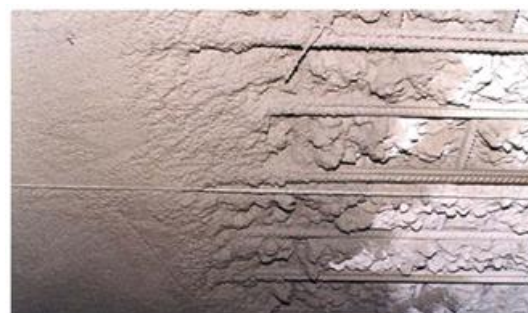
Fig 1.2: concreting of fire damaged slab

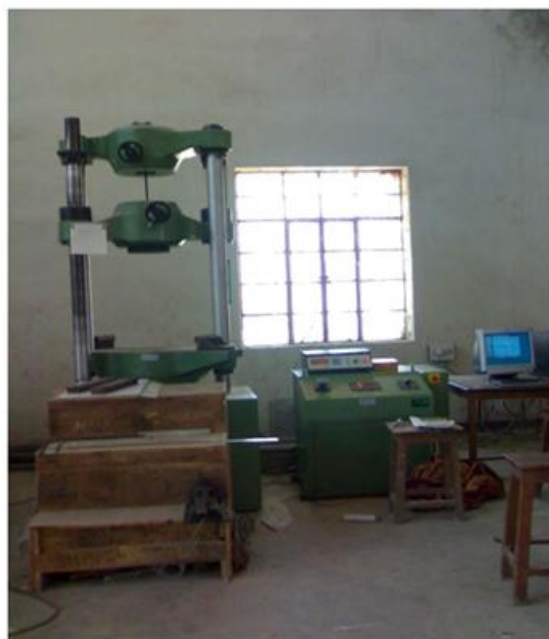
Fig 2.1: UTM testing setup

The 12mm steel bar is cut to a length of 40 cm and gave a gauge length of 60mm. The specimen is fixed on the machine and the required data on the computer is given. Test is conducted at a load rate of 300 kg/min for all the specimens. An extensometer is fixed to the specimen during the test to read the elongation. The data of the test is noted in computer during the test by default s it is setup.

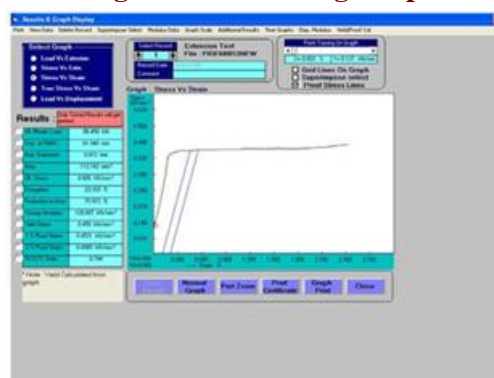
Fig 2.2: Screenshot of the result of tensile test using UTM

The graph of load versus deformation and load versus elongation is drawn on the computer. After the test all the other parameters like ultimate load, maximum extension in mm, area in mm², ultimate stress, elongation in percent, reduction in in area, young's modulus, yield stress, .1% and .2% proff stress and many other parameters can be observed.

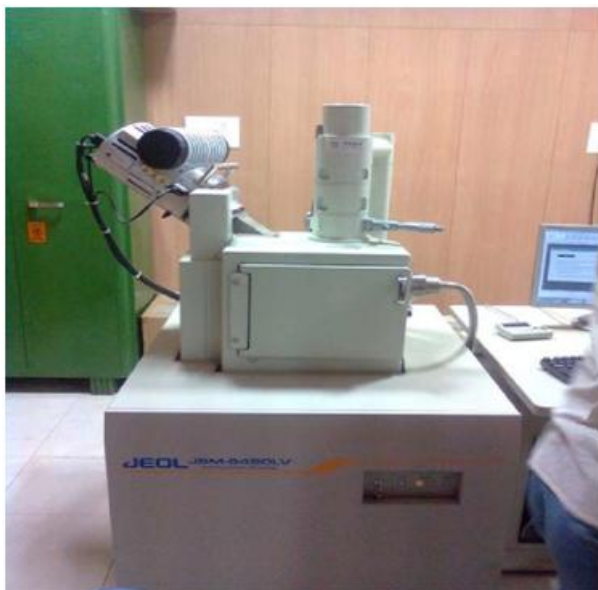
Fig 2.3: Setup of SEM

Scanning Electron Microscopy has done by JSM-6480LV at magnification of 5 microns (x5000) and 10 microns (x1000). The specimens are made in a size of 12mm diameter and 10mm length. Before testing the specimens are to be finely polished in all the edges and neatly cleaned with acetone for the clear view of the grain size and grain structure.

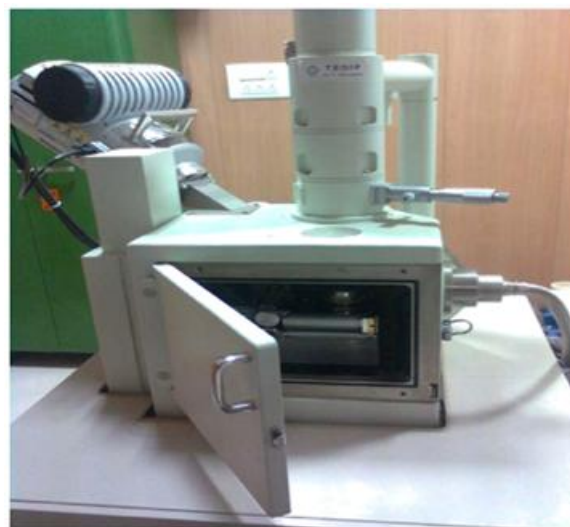
Fig 2.4: Inner view of SEM

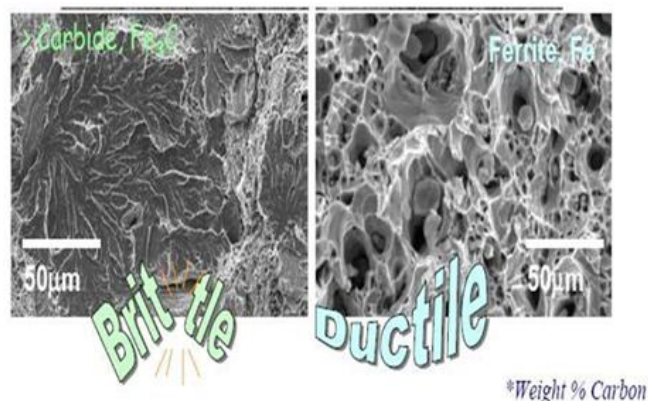
Fig 2.5: SEM properties of steel bar

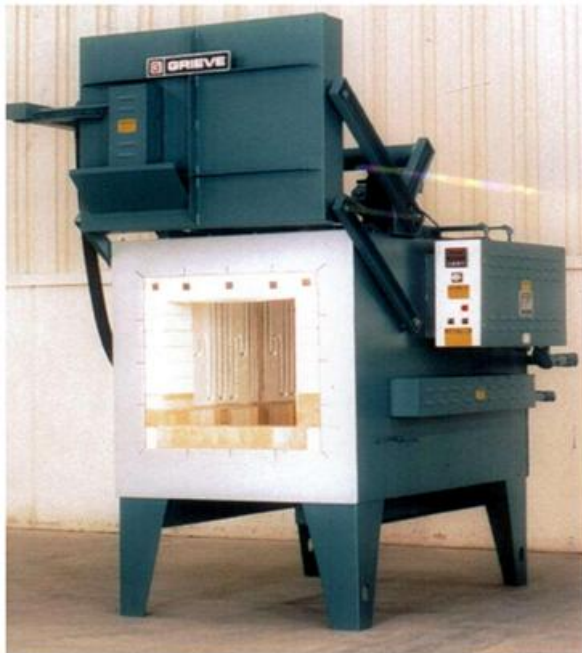
Fig 2.6: Electric furnace

The electric furnace is used to heat the specimens. The maximum temperature attained in this furnace is 1000°C. The inner depth of the furnace is 45mm. initially the furnace is heated to the required temperature by switching on it and when the required temperature is attained then 6 specimens put inside with the door closing tightly so that no air enter inside. The specimens are kept for a duration of 1 hour inside the furnace and later 3 specimens are quenched in water for rapid cooling and the other 3 are kept aside for atmospheric time. The 3 specimens which are quenched in water are removed after 15 minutes. Each time 6 bars are kept at temperatures of 100°C, 300°C, 600°C, 900°C and the same is repeated.

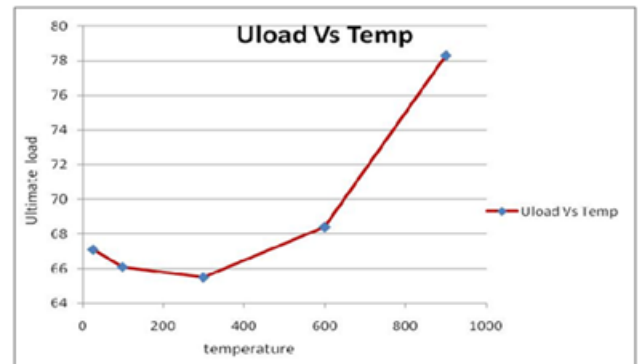
Fig 3.1: Temperature vs ultimate load

From the graph it can be observed that the ultimate load initially decreases from and then gradually increases, this happens due to the microstructure of the bar. For high temperatures the grain size decreases.

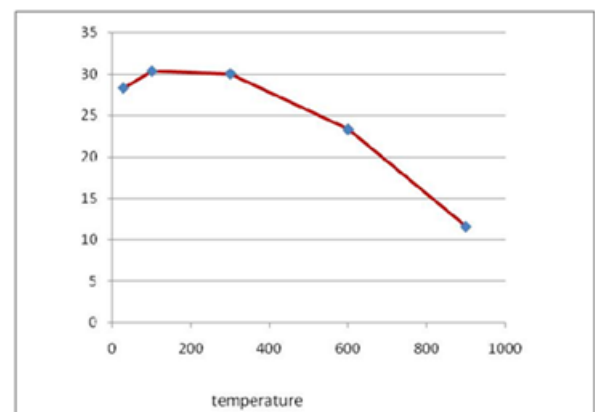
Fig 3.2: Temperature vs% elongation

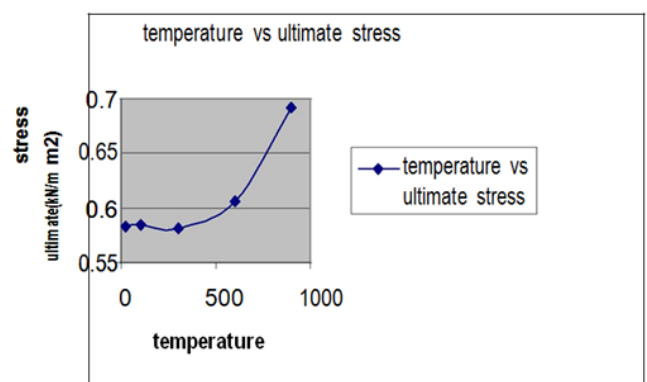
Fig 3.3: Temperature vs Ultimate stress

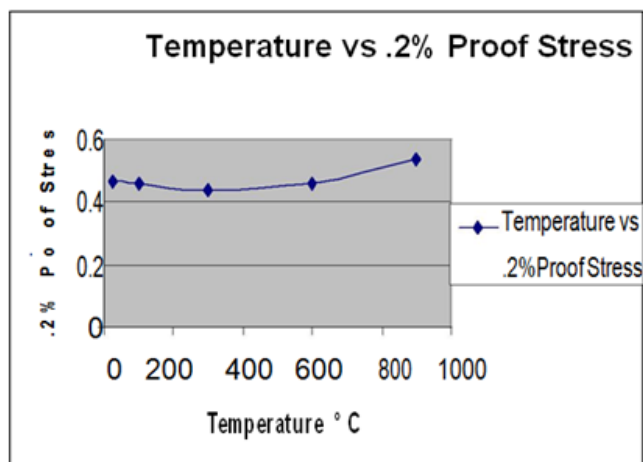
Fig 3.4: .2%Proof stress vs temperature

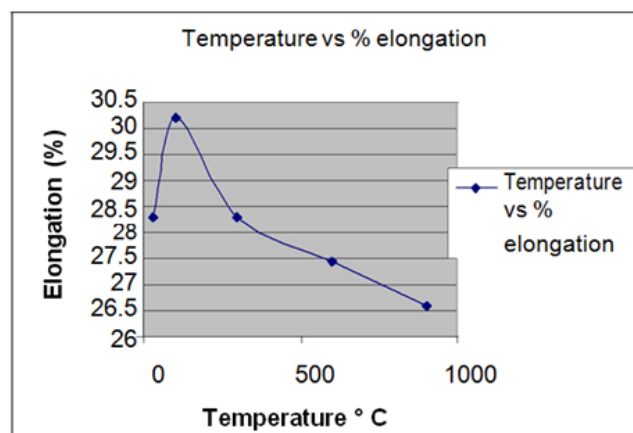
Fig 3.7: temperature vs elongation

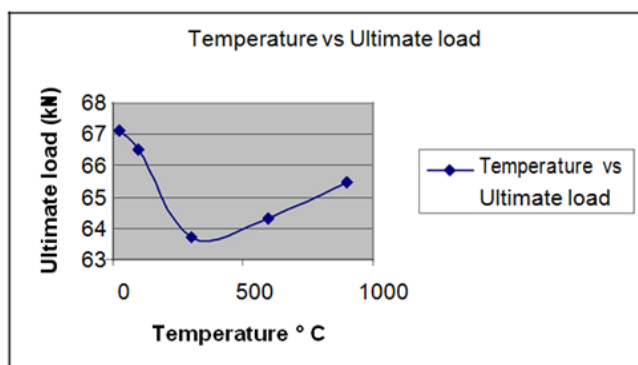
Fig 3.5: Temperature vs Ultimate load

From the Fig 3.5, the ultimate load carrying of the specimen was reduced from the specimen before heating.

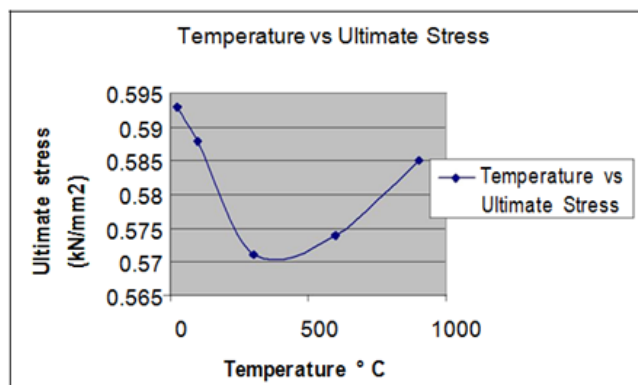
Fig 3.6: Temperature vs Ultimate stress

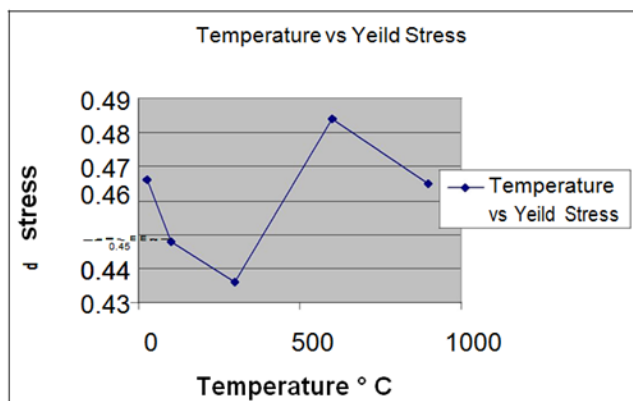
Fig 3.8: Temperature vs yield Stress

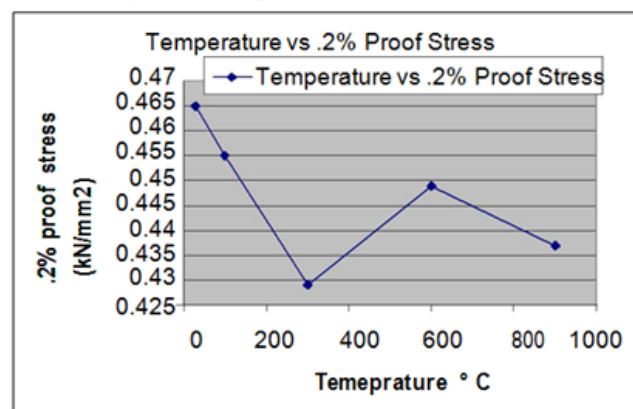
Fig.3.9: Temperature vs .2% Proof stress

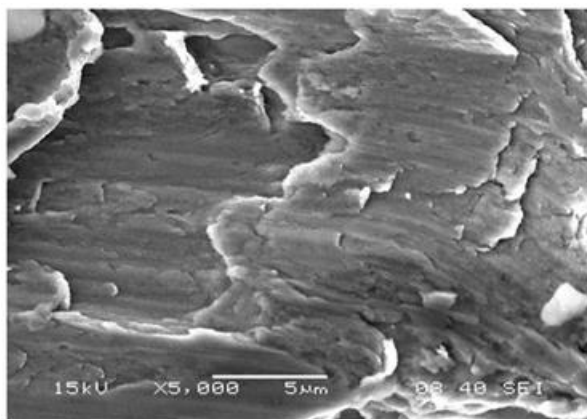
Fig 3.10: 100° C Ordinary cooling at magnification of 5 microns

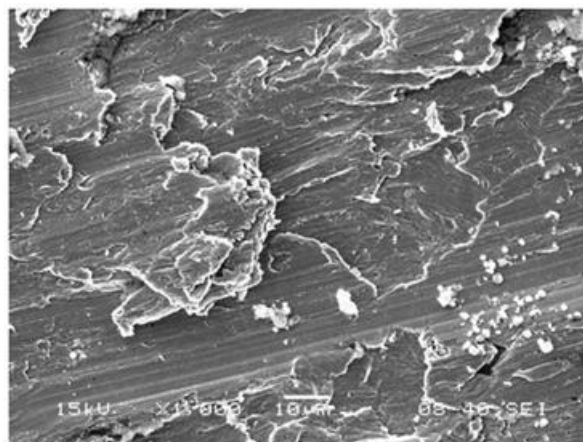
Fig 3.14: 300° C Rapid cooling at magnification of 10 microns

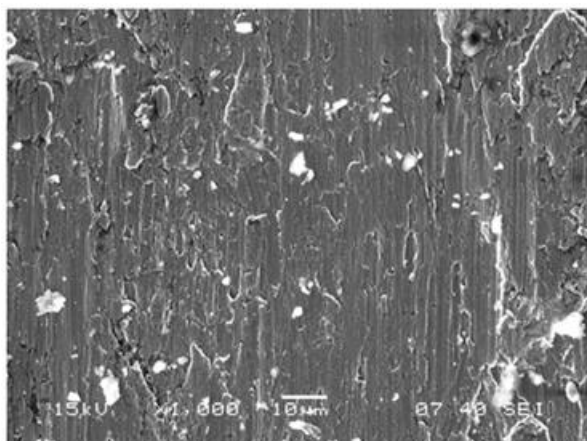
Fig 3.11: 100° C Ordinary cooling at magnification of 10 microns

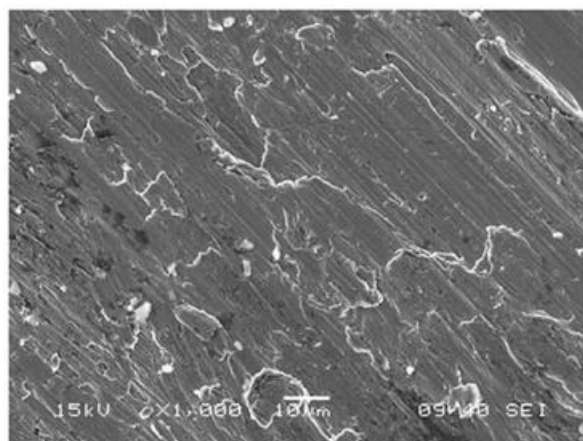
Fig 3.14: 900° C ordinary cooling at 10 micron

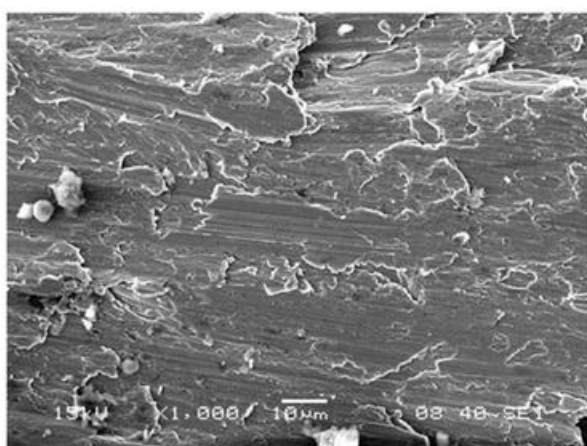
Fig 3.12: 300° C Ordinary cooling at magnification of 10 microns

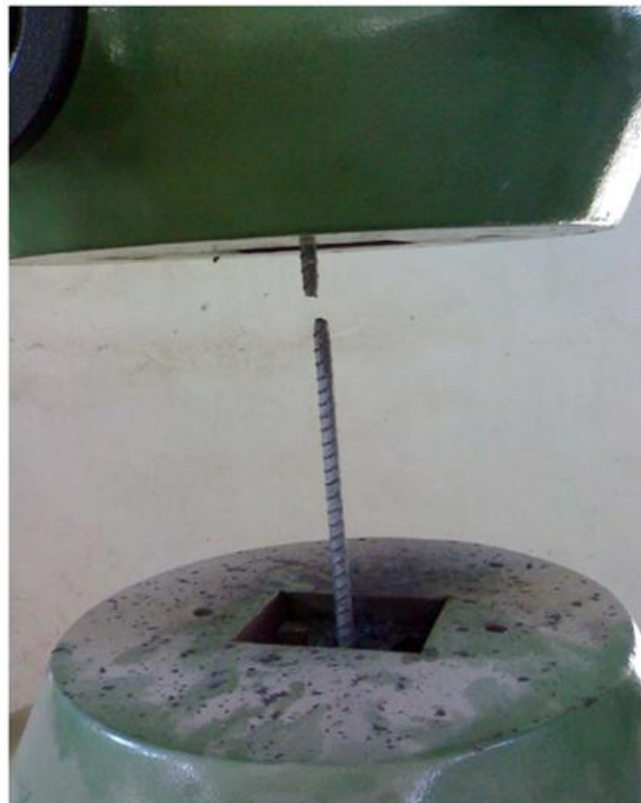
Specimen failed on UTM

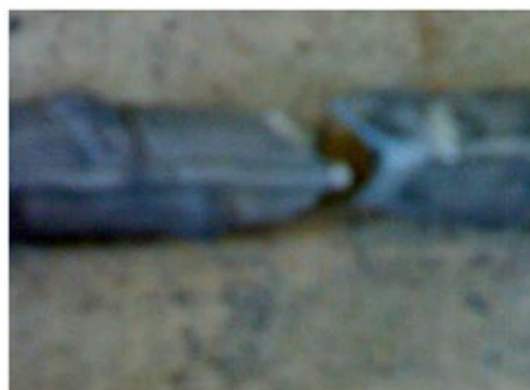
Failed specimen

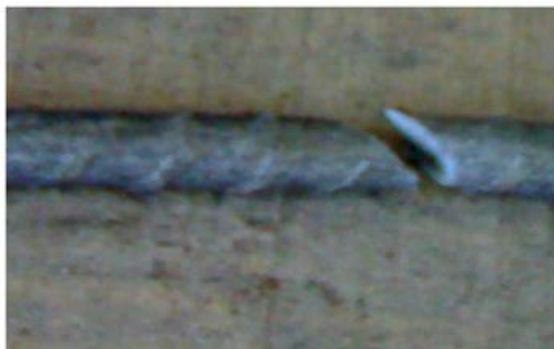
Shear failure of specimen
